# Service Bulletin

## TDI 3.0L V6 Exhaust Connection Removal and Installation

Y21-0027

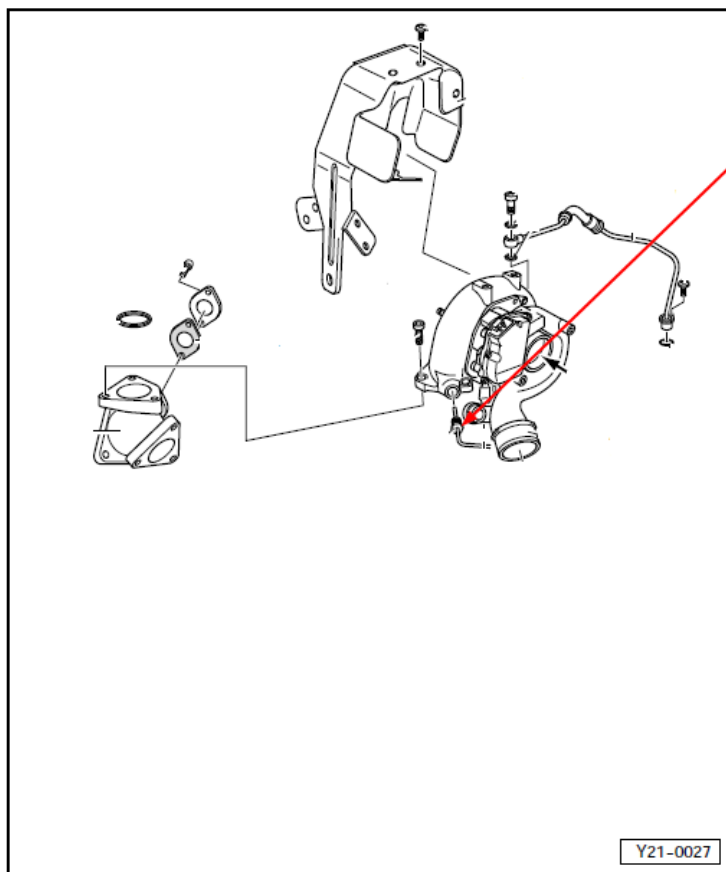
- Exhaust gas temperature sender 1 (G235), 45 Nm  
◆ Check ⇒ Page 23-90

6. Check torque on the exhaust gas temperature sensor. Torque to 45 Nm.
